September 29, 2025

Project/File: 123317662

Lily Dam, M.Eng., P.Eng. The City of Red Deer Box 5008 Red Deer, AB T4N 3T4

Reference: 2025 Geohazard Site Inspections Summary for Various Sites in the City of Red Deer, Rev. 0

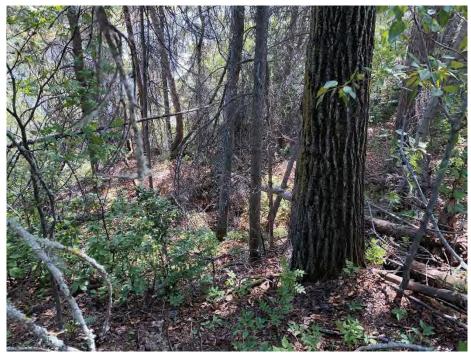
- No observable change from Stantec's 2022 call-out inspection. No signs of erosion or slope movement were observed. The slope was generally well vegetated (Photos 1, 2 and 3).

Photo 1: Old slope failure, well vegetated. Looking downslope (southeast).

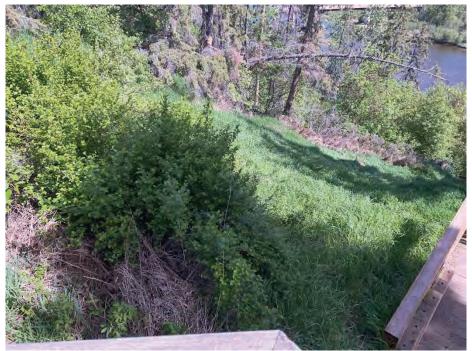
Photo 2: Well vegetated riverbank next to trail / stairs, east of the Heritage Ranch building. Looking northeast.

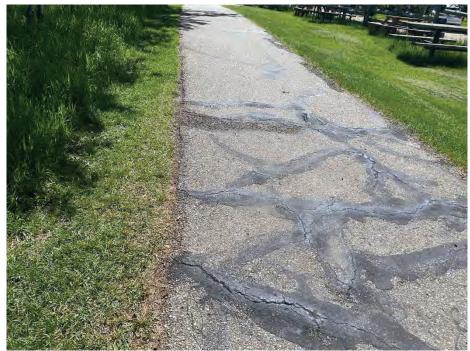
- Some asphalt cracking was observed on the pedestrian trail northwest of the Heritage Ranch building (Photo 4). The cracking is likely unrelated to slope movement.

Photo 4: Sealed cracks in asphalt pedestrian trail, looking southeast.

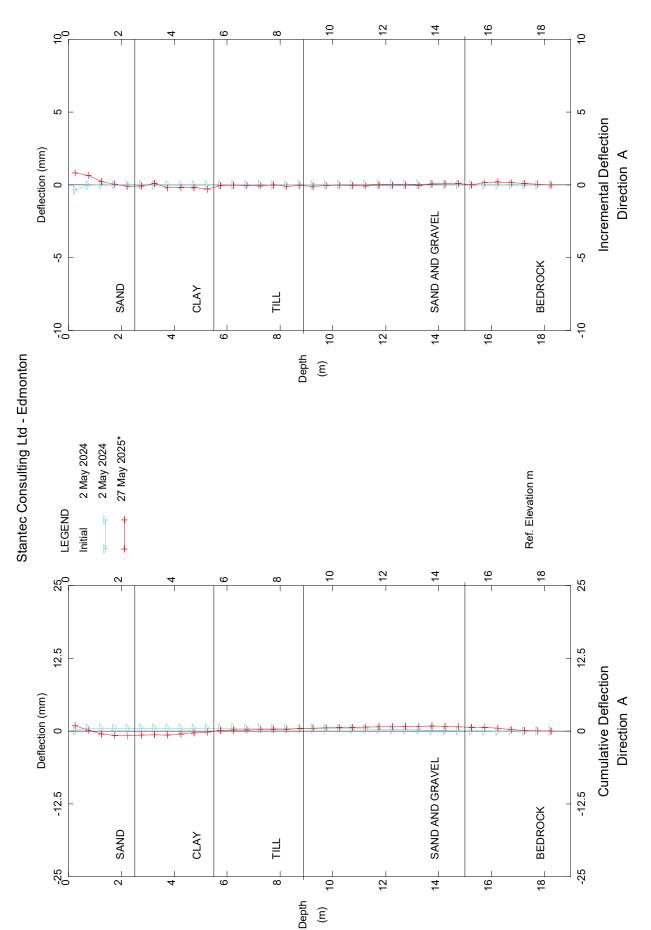
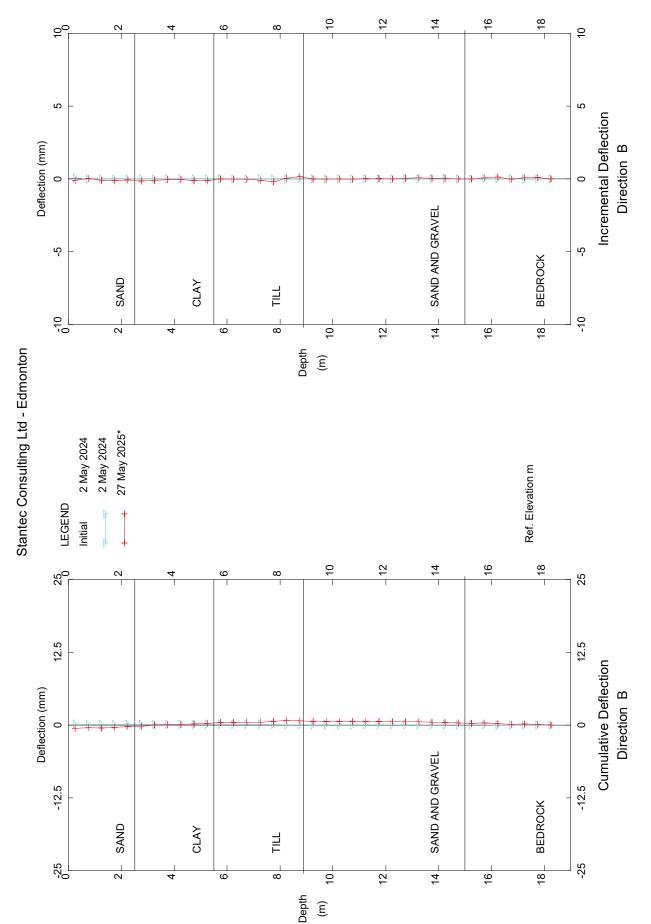
CRD Site 01, Inclinometer SI12-3

- A section of the toe of the slope is armoured with riprap (Photo 5).
- Slope Inclinometer (SI) SI12-3 was monitored during this inspection. Since baseline readings taken by Stantec in May 2024, no apparent zones of movement have been observed. The observed movement is minimal and likely reflects noise rather than slope movement.

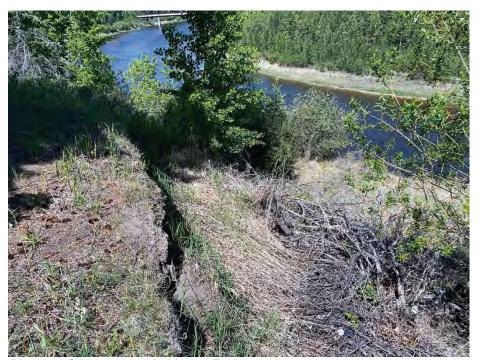
Photo 2: Slide area behind Lot 7. Facing west.

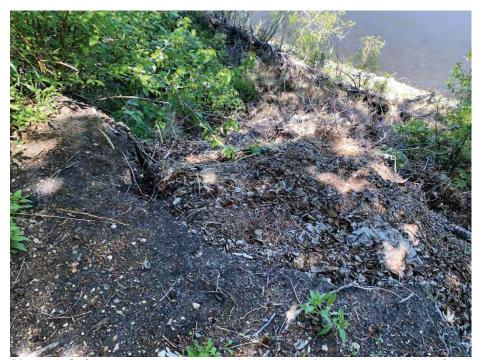
Photo 4: Soft, spongy ground at crest behind Lot 10, and accumulation of discarded brush on slope. Facing northeast.

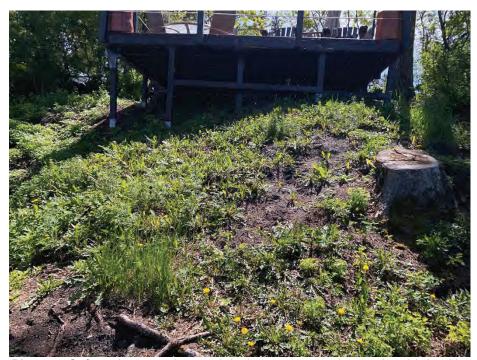
Photo 6: Soft, moist ground around deck structure on slope at Lot 14. Looking south (upslope).

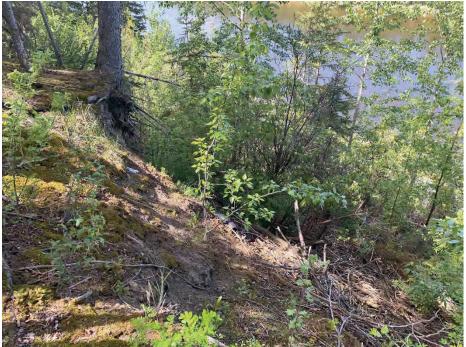
Photo 7: Historical slide behind Lot 15. Facing northwest.

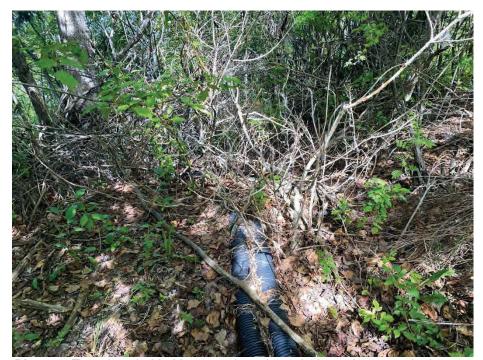
Photo 8: Two pipes behind between Lots 15 and 16 running towards river slope. Facing north.

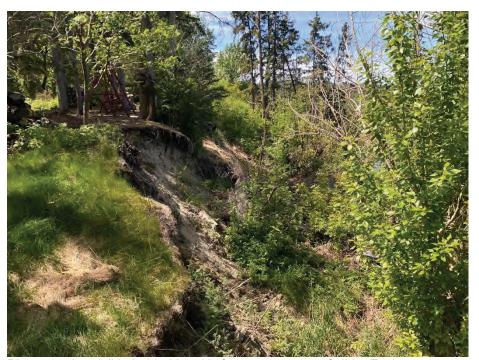
Photo 12: Landslide behind Lot 18, from east extent of slide. Facing west.

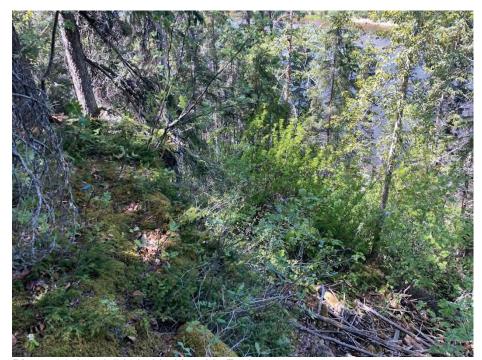
Photo 14: Landslide behind Lot 20. Facing west.

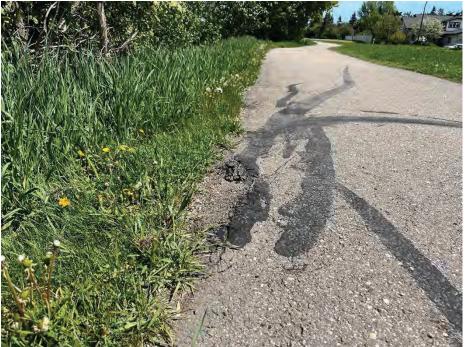
Photo 19: Cracking and heaving on edge of asphalt trail at east end of Warwick Drive. Looking east.

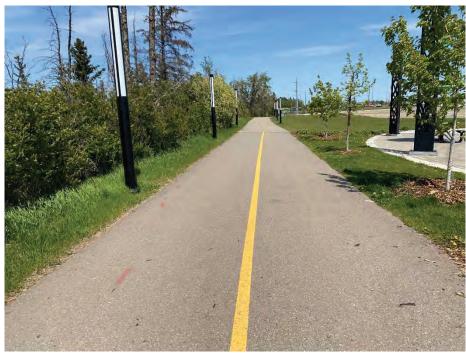
Photo 1: Trail asphalt in good condition. Facing northeast.

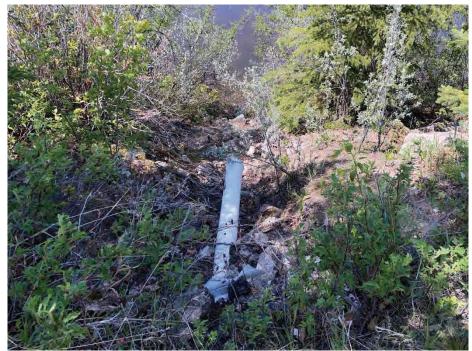
Photo 2: Northeast outfall directing into 150 mm PVC pipe. Erosion channel is approximately 1-2 m wide below the outlet. Looking west.

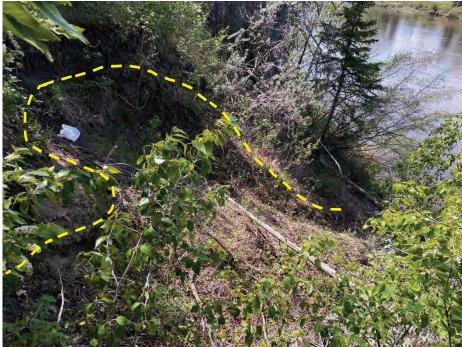
Photo 3: Northeast historical failure. Looking north.

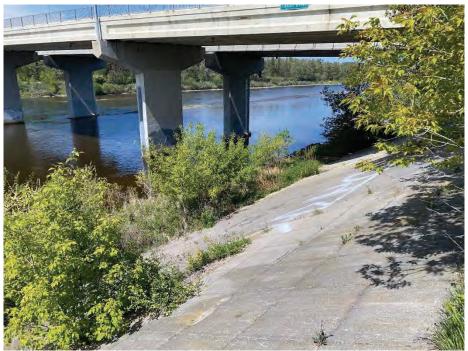
Photo 4: Taylor Drive Bridge and concrete slab armouring on headslope. Looking north.

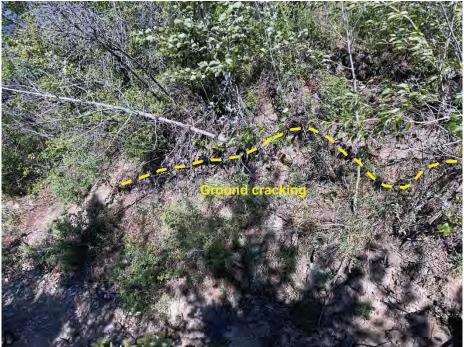
Photo 5: Slope failure at northeast end with ground cracking near crest. Facing northeast.

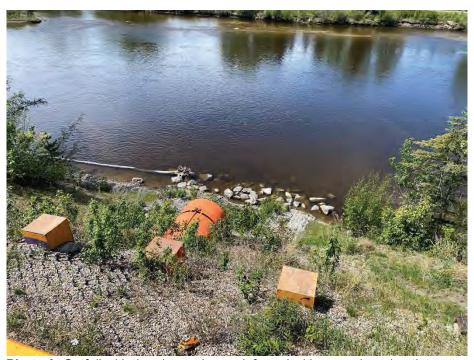
Photo 6: Outfall with the above slope reinforced with geoweb and outlet area protected by articulated concrete blocks at middle of site. Facing north.

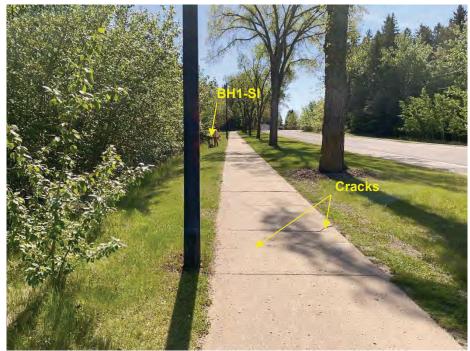
Photo 2: Sidewalk cracking above the embankment area. Facing east.

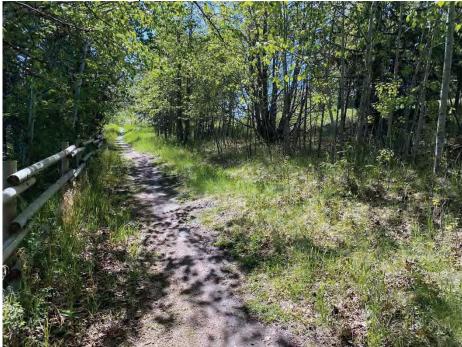
Photo 3: Trail above landslide area. Facing southeast.

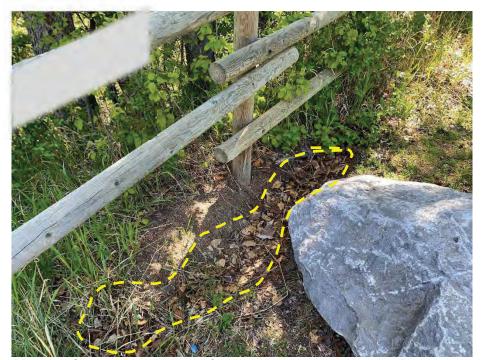
Photo 4: Ground crack near trail fence midway up embankment. Facing east.

- Regrade ground depressions along the trail fence to reduce ponding water and surface water infiltration.
 No additional fill should be placed for regrading. Any vegetation removed for regrading should be reinstated to maintain slope stability.
- Stantec recommends the inspection frequency remain at once every 5 years or "as needed".

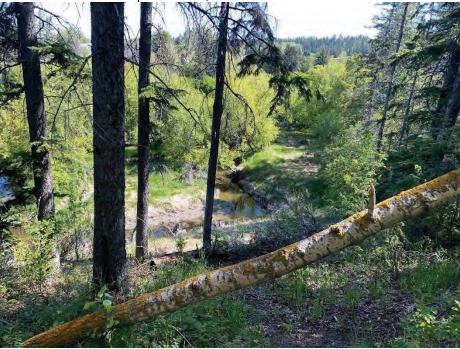
Photo 5: View of Waskasoo Creek bend from midway up embankment slope. Facing northeast.

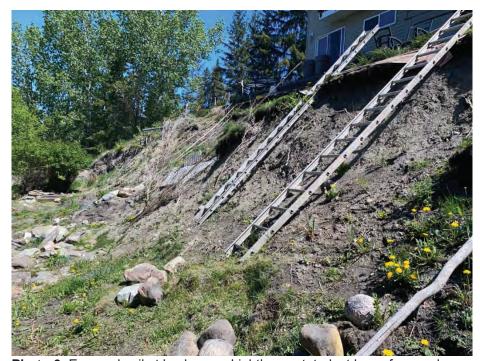
Photo 6: Exposed soil at backscarp. Lightly vegetated, at less of an angle. Facing northeast.

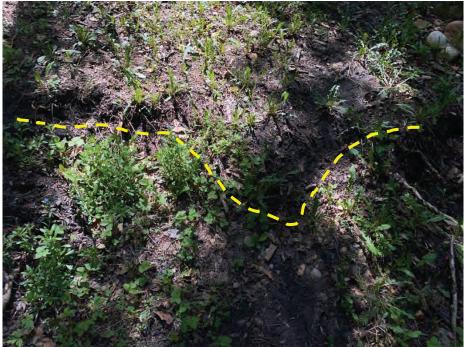
Photo 9: Open cracks in landslide mass, looking south.

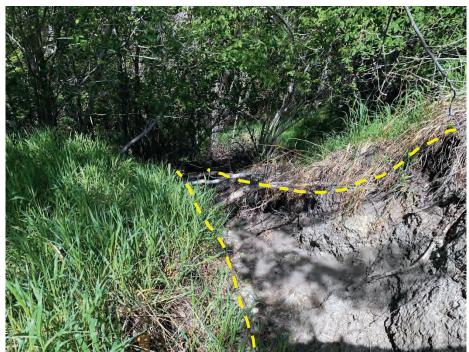
Photo 10: Erosion channel on north end of scarp, heading downslope. Looking northwest.

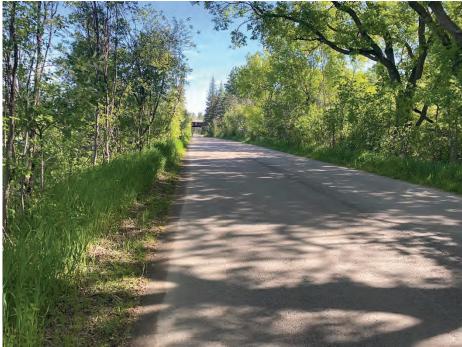
Photo 1: 45th Avenue asphalt in good condition. Looking north.

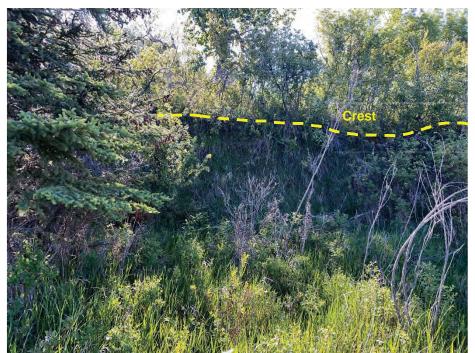
Photo 2: Historical failure north of the Kerry Wood entrance. Facing northeast.

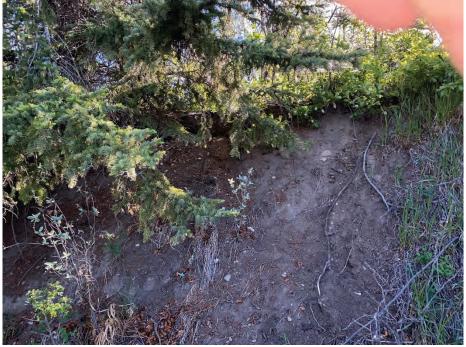
Photo 5: Exposed scarp face on historical failure north of the Kerry Wood entrance. Looking east.

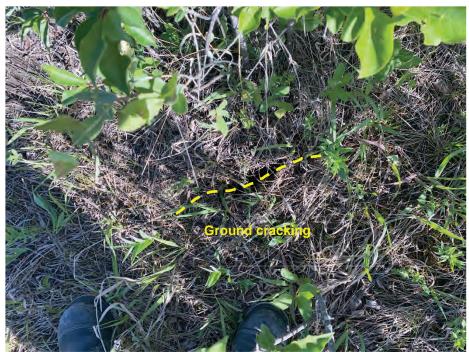
Photo 6: Ground crack near historical failure, 1.5 m away from crest. Facing north.

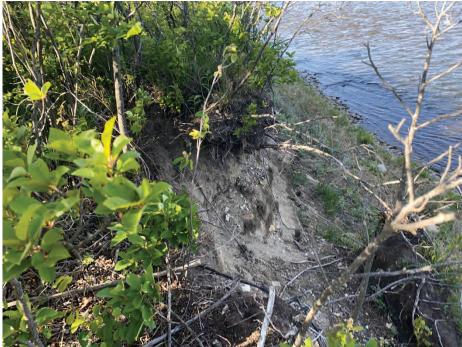
Photo 9: Exposed sandy soil face at failure south of the Kerry Wood entrance. Facing south.

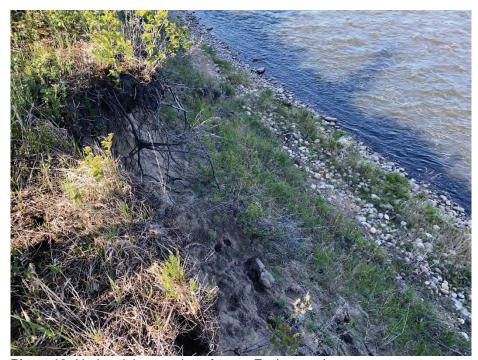
Photo 10: Undermining at edge of crest. Facing southwest.

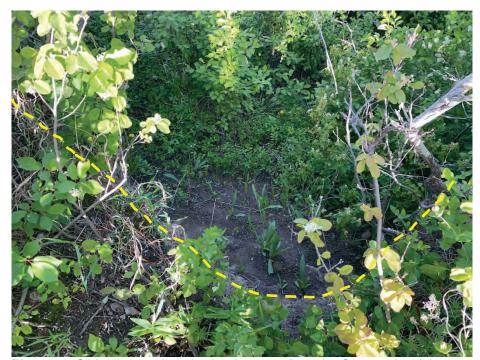
Photo 14: Slide observed on riverbank across from the Community Living Society building. Facing northwest.

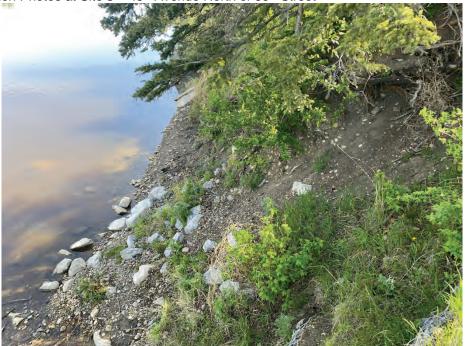
Photo 15: South historical failure area, near 59 Street. Facing northeast.

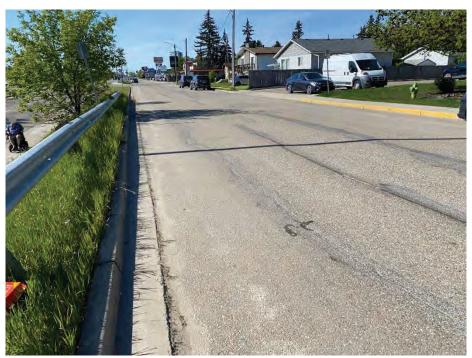
Photo 1: Sealed cracks on Gaetz Ave Service Road. Facing south from midsection.

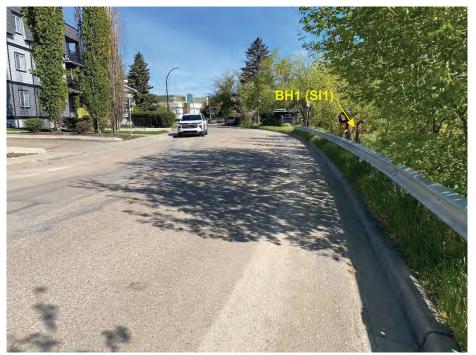
Photo 2: Sealed cracks on Gaetz Ave Service Road. Facing northwest from mid-section.

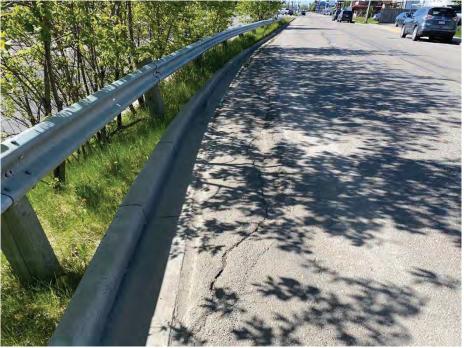
Photo 3: Cracks and surface depression on Gaetz Ave Service Road. Facing south.

- Seal pavement cracks to reduce surface water infiltration into the slope.
- The slope appears to be relatively slow moving and has not impacted any structures or City infrastructure at this time. However, additional creep of the slope or slumping due to land use, wet weather, etc., may result in loss of infrastructure. Potential remediation options for the slope may include slope flattening (reducing the service road to a single lane), removal of the landslide mass and replacement with engineered fill, reinforcing the slope with soil nails, or constructing a retaining wall.

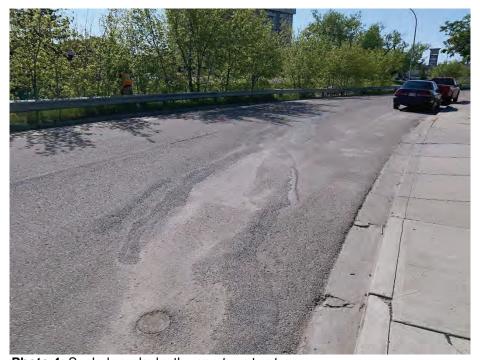
Photo 4: Sealed cracks by the apartment entrance.

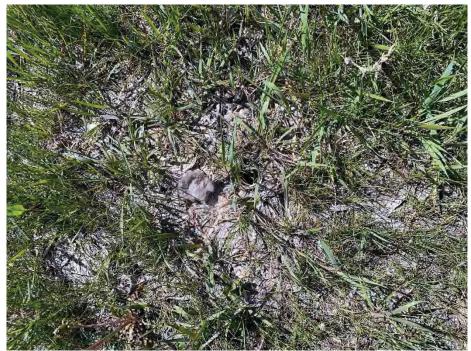
Photo 6: Damaged BH2 standpipe.

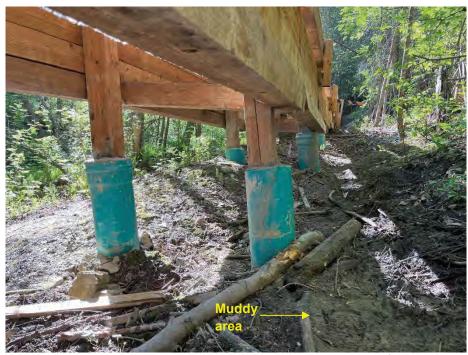
Photo 3: Damaged section of wooden walkway north of 4806 36th Street. Looking southeast.

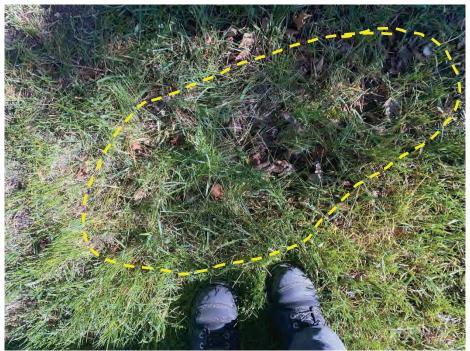
Photo 4: Ground depression northeast of Lot 4. Facing north.

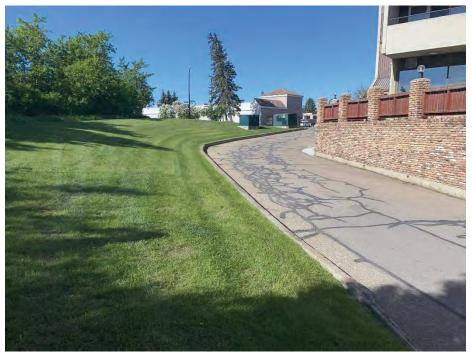
Photo 7: Access road east of apartment complex with sealed cracks. Facing southwest.

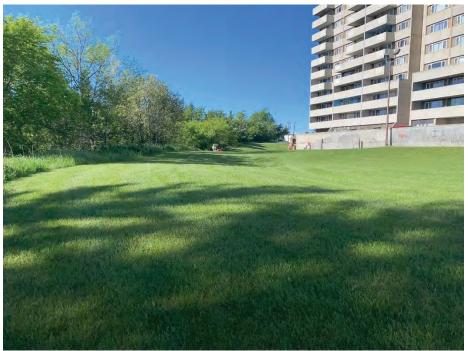
Photo 8: Area at top of slope, east of apartment complex. Facing southwest.

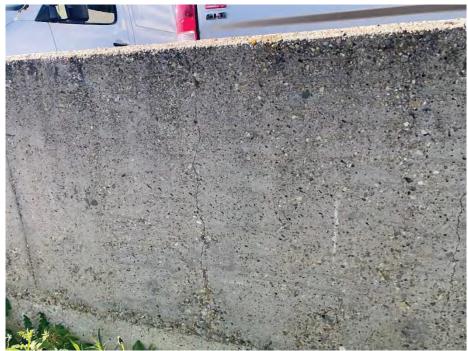
Photo 10: Hairline cracks in concrete parking wall of the apartment complex. Facing southwest.

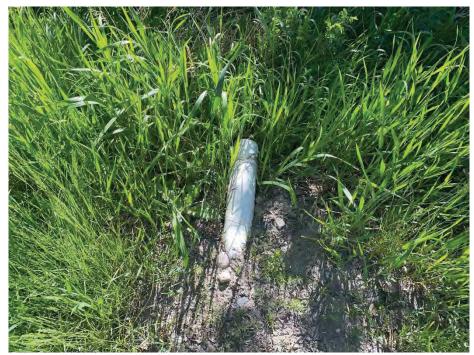
Photo 11: PVC drainage pipe east of former Elks building directing onto slope. Facing east.

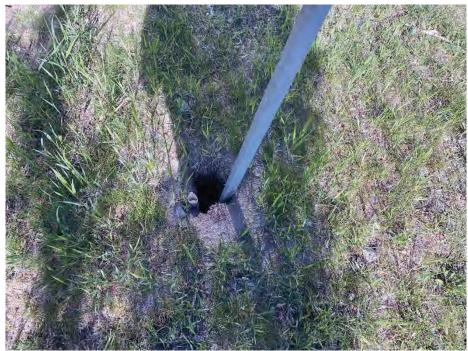
Photo 12: Hole with stake and broken PVC standpipe east of former Elks building. Facing south.

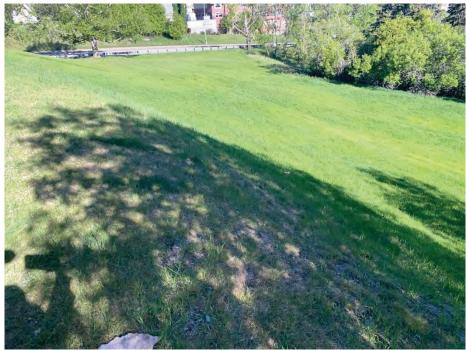
Photo 13: Slope north of restaurants. Facing northwest.

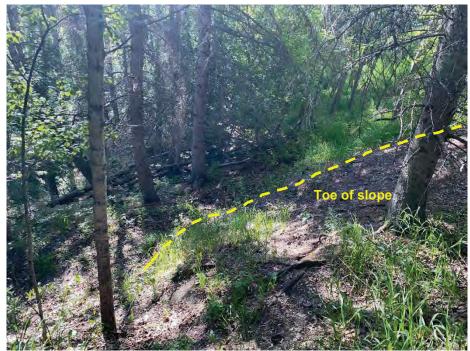
Photo 14: Historical failure northeast of former Elks building. Facing west.

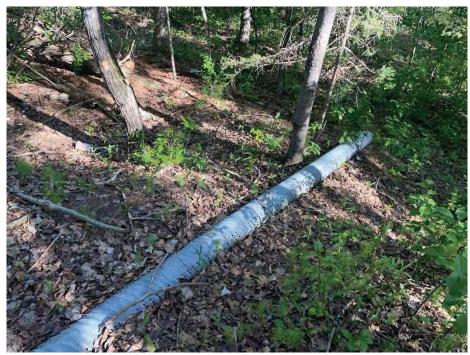
Photo 15: Perforated CSP drain northeast of former Elks building directed downslope. Facing northwest.

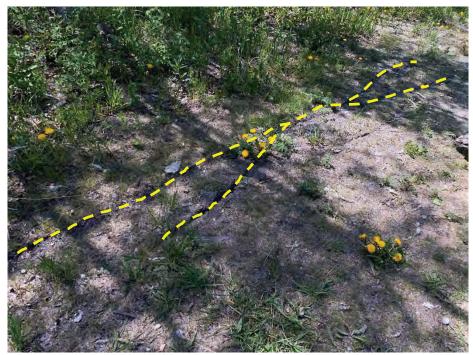
Photo 1: Ground cracking and erosion down west slope on informal trail. Looking southeast.

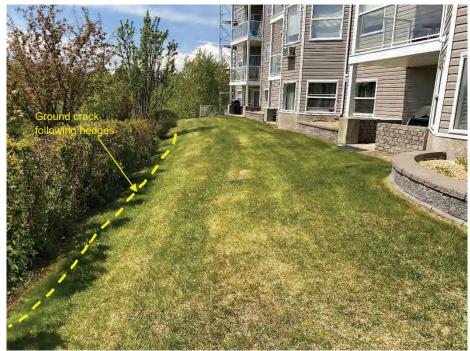
Photo 2: South yard. Looking west.

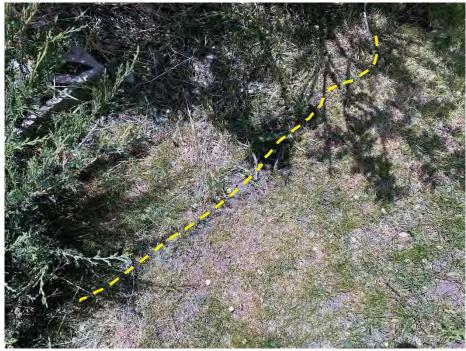
Photo 7: Old ground crack on south slope. Looking northeast.

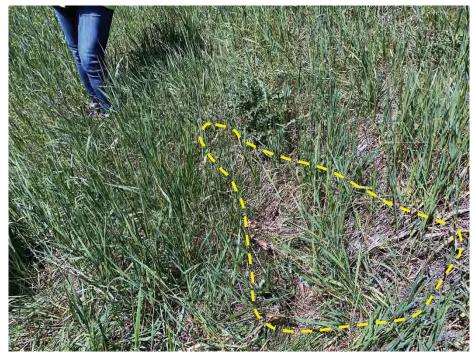
Photo 8: Small depression on south slope face, close to the toe. Looking northwest.

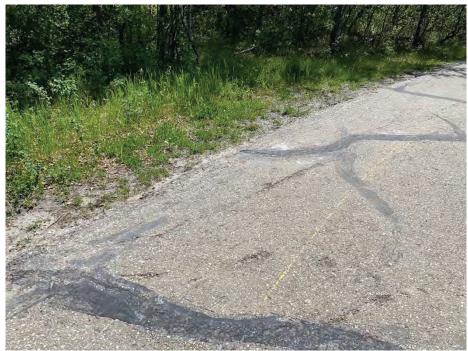
Photo 12: Creek pedestrian trail with some sealed and some open cracks. Looking south.
