Final Report

Master Drainage Plan

Queens Business Park – Hazlett Lake

Westhoff Engineering Resources, Inc.

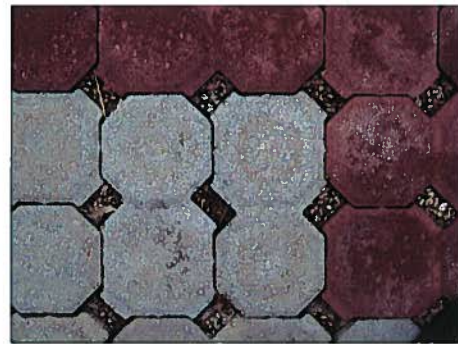
Porous Pavement

Contains void space for stormwater infiltration, thereby reducing runoff

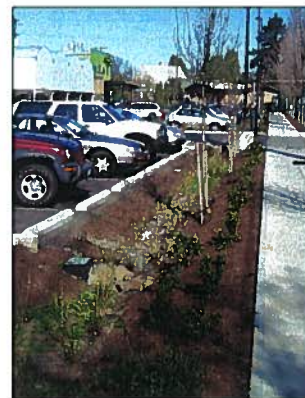
Vegetated Parking Medians

This technique incorporates stormwater quality treatment and flood detention through the vegetation of shallow depressions in medians

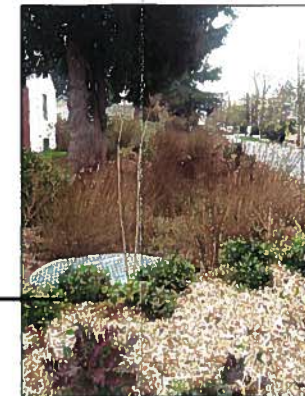
Landscaped Bioswales

Drainage from public roads via bioswales in private/public common areas (as shown). Provide water treatment and conveyance as well as improve site aesthetics

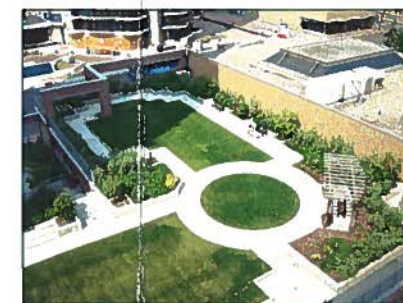
Green Roofs

Green roofs contain vegetation to treat and reduce runoff.

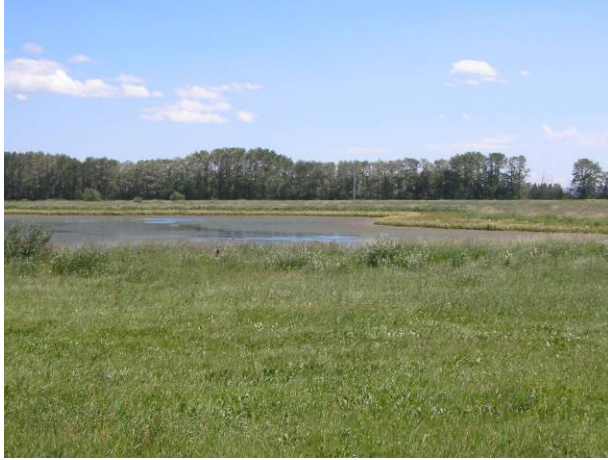
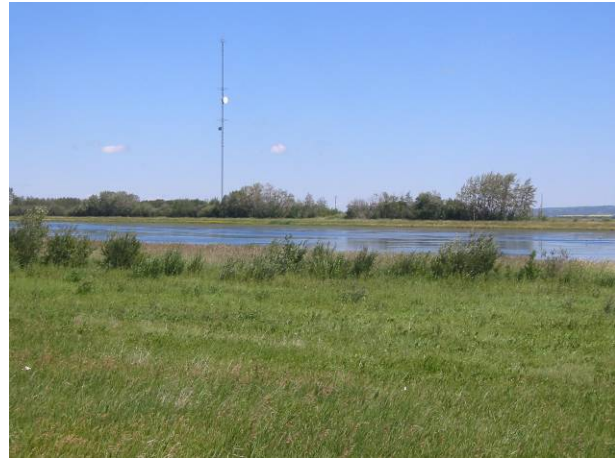
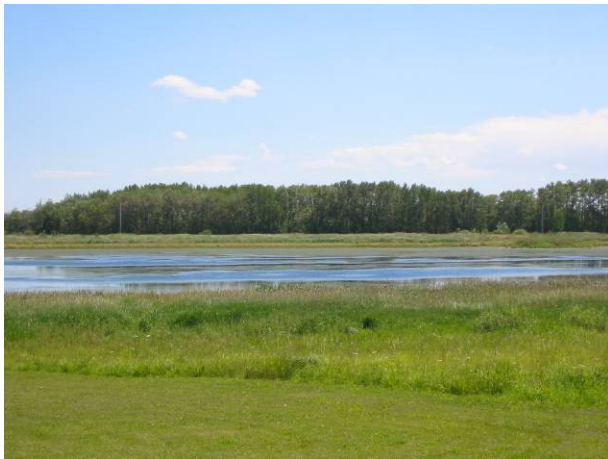
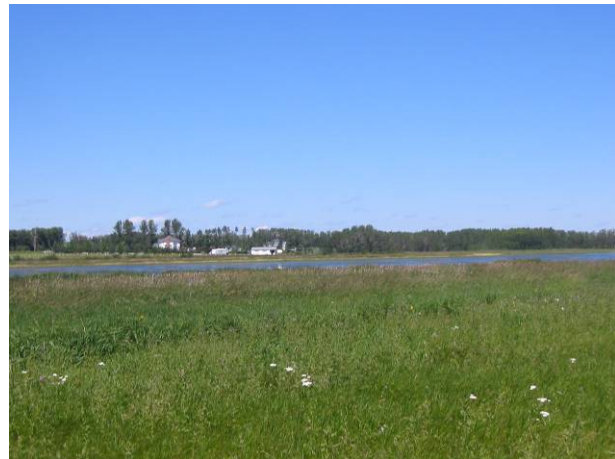
Cameo Lake

- Large wetland, significant area of open water
- Cattails, tall grasses and willows surrounding
- Wide riparian zone ~ 30m in some areas
- Songbirds heard, waterbirds likely use for nesting area
- Environmental Significance: **Major Wetland** – moderate to little disturbance evident, predominantly native vegetation, may act as staging area for wildlife movement, moderate contribution to flood and erosion control, moderate contribution to long-term maintenance of hydrological regime beyond its boundaries
- Class V – Permanent Pond/Lake

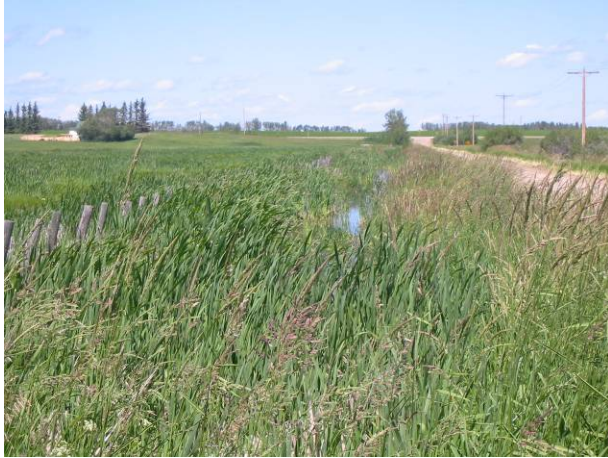
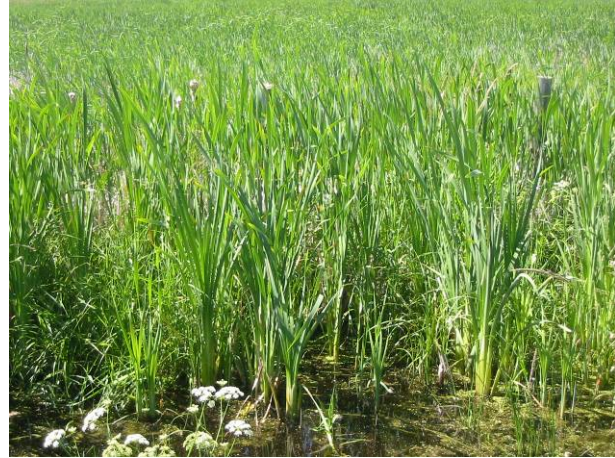
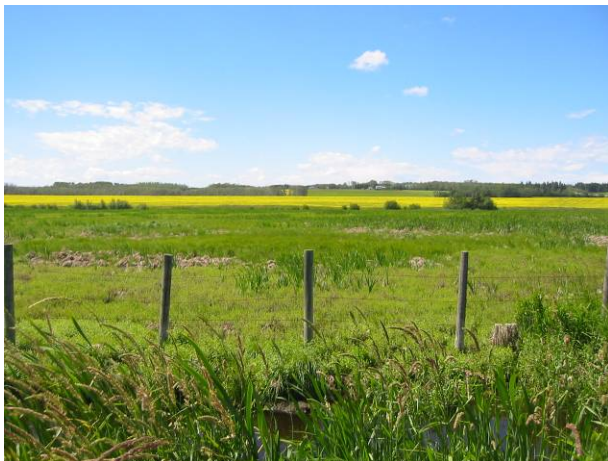
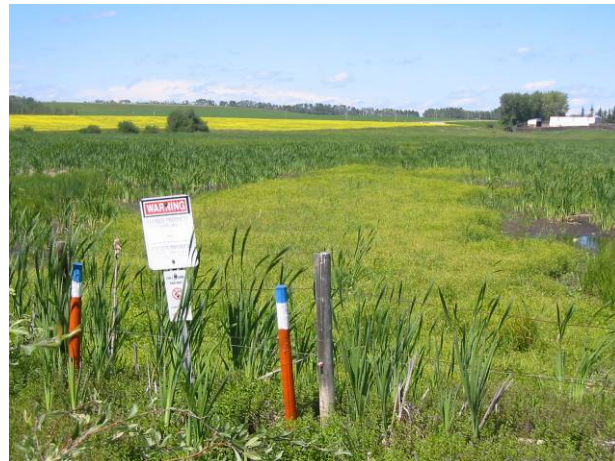
West side of local road

- Standing water in ditch
- Cattails dominant, sedges, willows and poplar surrounding
- Pipeline has been put through wetland, obvious soil/vegetation change but affected area relatively small
- Songbirds heard
- Environmental Significance: **Supporting Wetland** - moderate disturbance evident, low importance for wildlife staging area, provides habitat for wildlife, low to moderate contribution to flood and erosion control
- Class IV – Semi-permanent Pond

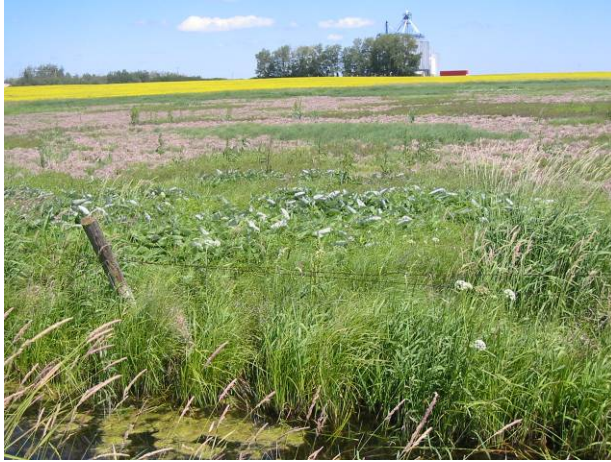
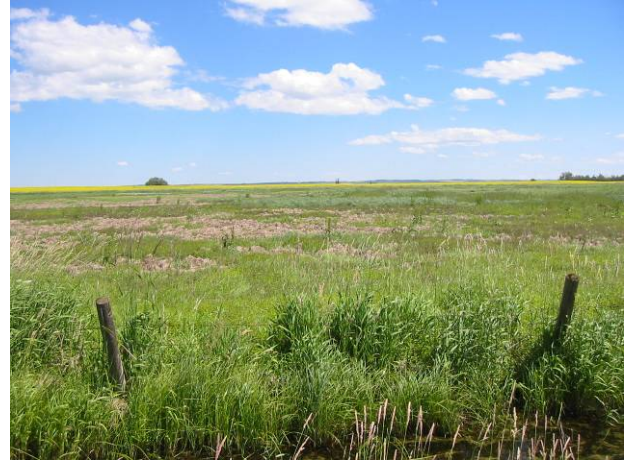
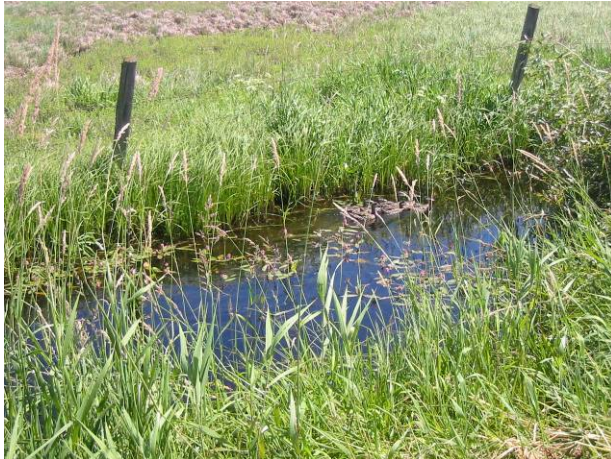
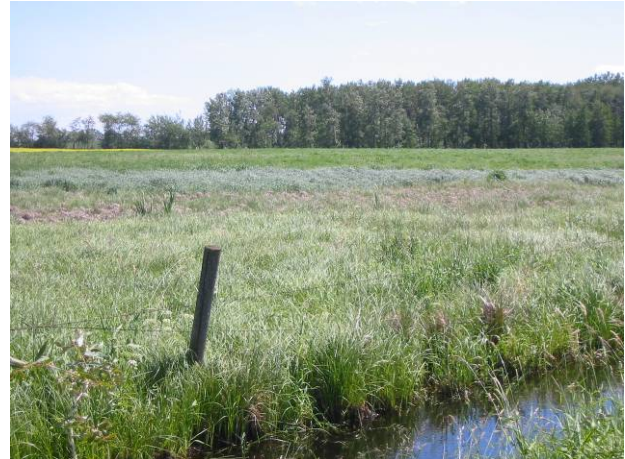
East side of local road

- Standing water in ditch, ducks seen in ditch
- Shallow-marsh vegetation dominant, grasses surrounding
- Environmental Significance: **Supporting Wetland** – moderate disturbance evident, low importance for wildlife staging area, provides habitat for wildlife, low to moderate contribution to flood and erosion control
- Class III – Seasonal Pond

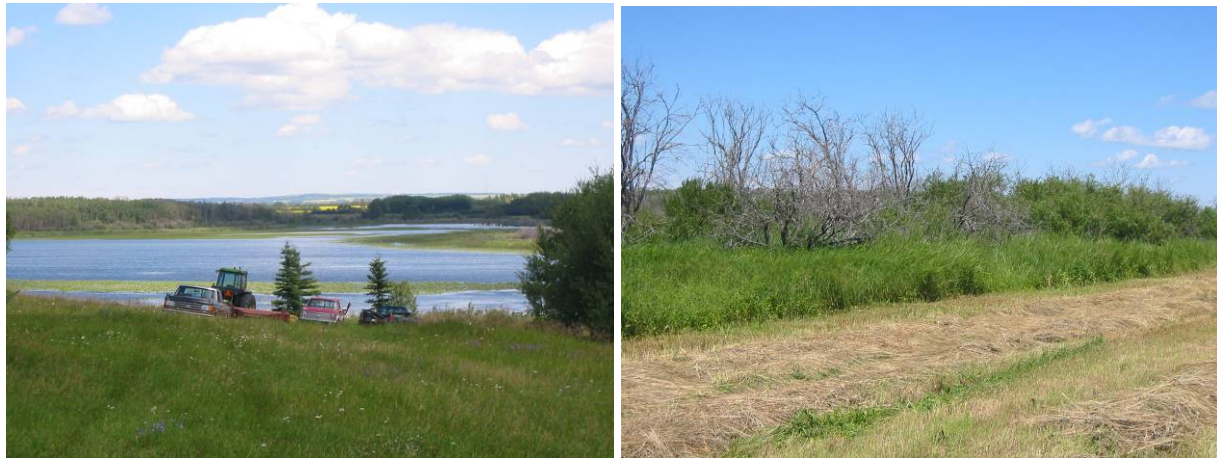
Hazlett Lake

- Large wetland, significant area of open water
- Wide riparian zone, willows, tall grasses on periphery
- Songbirds heard, likely used by waterbirds
- Environmental Significance: **Major Wetland** – moderate to little disturbance evident, predominantly native vegetation, may act as staging area for wildlife movement, moderate contribution to flood and erosion control, moderate contribution to long-term maintenance of hydrological regime beyond its boundaries
- Class V – Permanent Pond/Lake

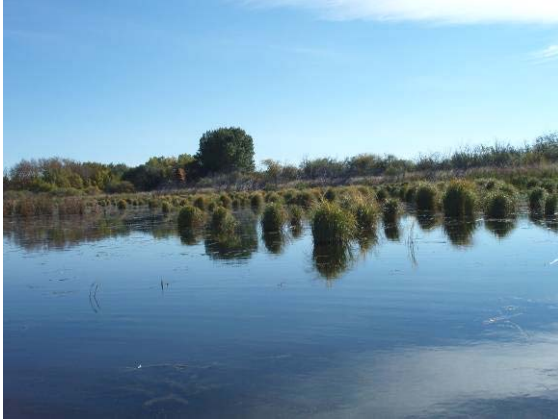
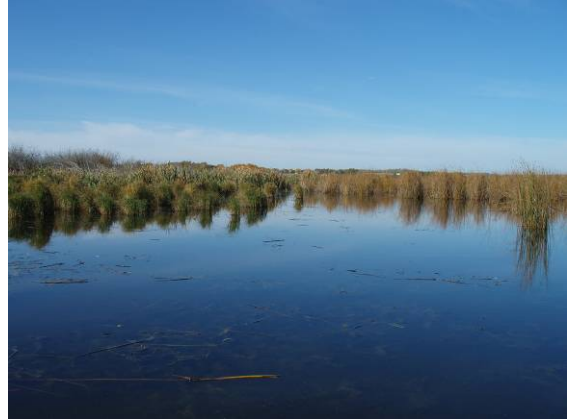
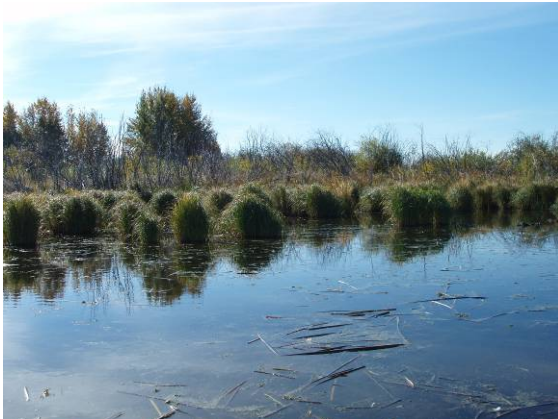
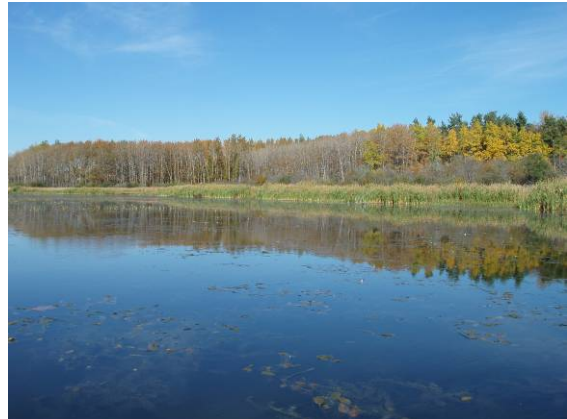
Northeast Lobe

This area consists of numerous dead willows. This would indicate that the current water level is higher than in the past, causing the willows to be drowned out and pushed back in recent years.

Along the north shore is a good example of a large mixed tree stand consisting mostly of balsam poplar trees. Their presence being close to the lake suggests that the water table is lower in this area and that the area is at a higher elevation.
