# VIEWPOINT GALLERY

## CULTURE SERVICES BUILDING

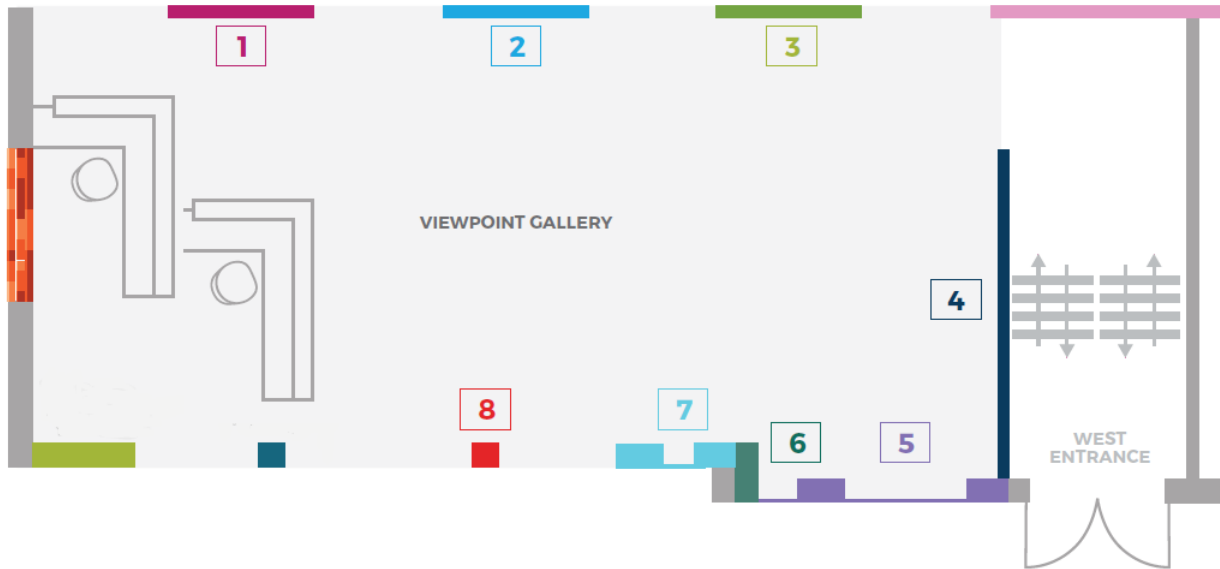
**1**

**W x H = 93" x 94"**

IMPEDIMENTS:

- emergency light fixture 8" down from ceiling
- thermostat and light switches 16 ¾" in from edge of wall
- rubber baseboards, 4 ½" high

OTHER MATERIAL CONSIDERATIONS:

- plywood under drywall - full wall
- opposite side of wall has partial band plywood layer

**2**

**W x H = 96 ½" x 94"**

- rubber baseboards, 4 ½" high
- OTHER MATERIAL CONSIDERATIONS:
- plywood under drywall - full wall
  - opposite side of wall has partial band plywood layer

**3**

**W x H = 93 ½" x 94"**

- emergency lighting fixture 8" from ceiling, off
- rubber baseboards, 4 ½" high

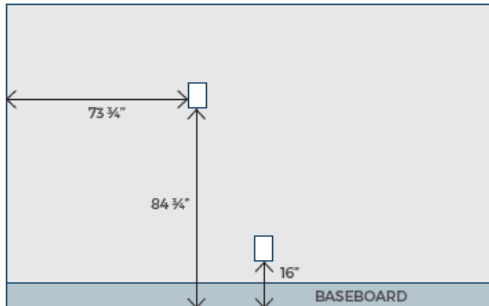
**4****W x H = 210" x 126"**IMPEDIMENTS:

- rubber baseboards, 4 ½" high
- fire alarm indicator: is 4 ¾" wide, 84 ¾" up from floor, 74 ¾" in from left wall edge, off centre
- outlet, 16" up from floor in centre of wall

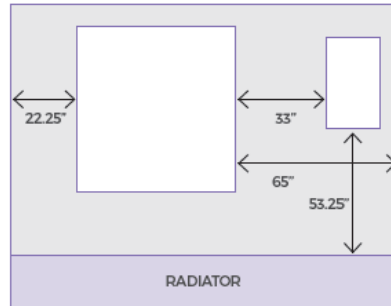
**5****W x H = 160 ¾" x 106"**IMPEDIMENTS:

- radiator - 5" deep, 20" high from floor
- large window + small window, upper right portion of wall

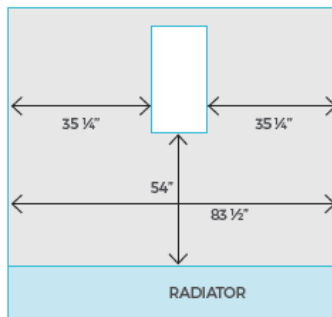
**7****W x H = 83 ½" x 106"**IMPEDIMENTS:

- radiator - 5" deep, 20" high from floor
- window, upper portion of wall
