3. Home Grill Building Statement of Significance

NEIGHBOURHOOD	Downtown	YEAR BUILT	1936
ADDRESS	4942 – 50 Street	ARCHITECT	-
LEGAL	H; 17; 3	CONTRACTOR	J.H. Murdock

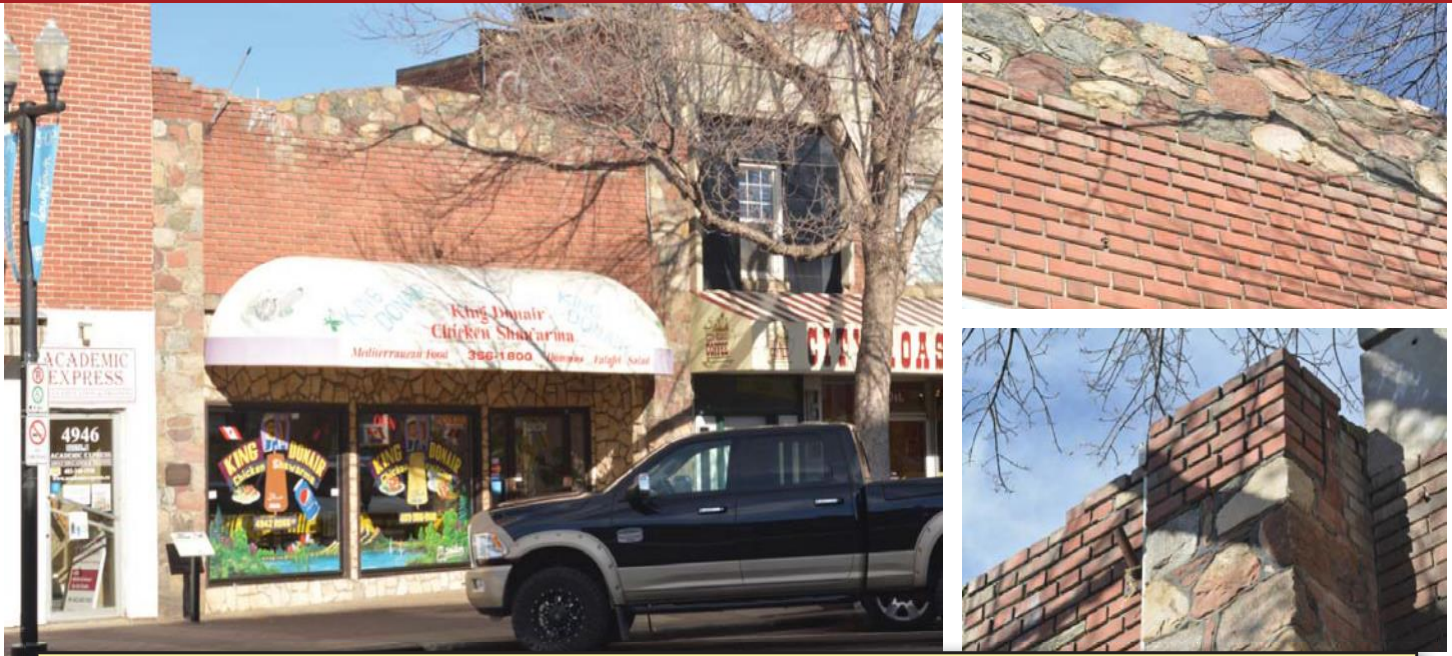
The Home Grill Building is a single-storey, brick commercial building situated in the commercial district of Red Deer’s historic Downtown neighbourhood. Located on the north side of Ross Street between 49 Avenue and Gaetz Avenue, the building is identifiable by its Flemish bond, red-brick false front façade with distinct stone detailing, large display windows facing the street and its original, internal stone fireplace.

The Home Grill Building overall is in good condition with its form, scale and massing intact. The portion of the front façade below the awning has been completely remodeled, but it retains the same function of the original display windows and entrance. There is a spray-painted tag located near the crest of the false front façade, but otherwise the front bricks and stone are intact. At the rear of the building, localized plant growth between the bricks was noted. There are also signs of mortar loss in the brick portion of the chimney located above the roofline.

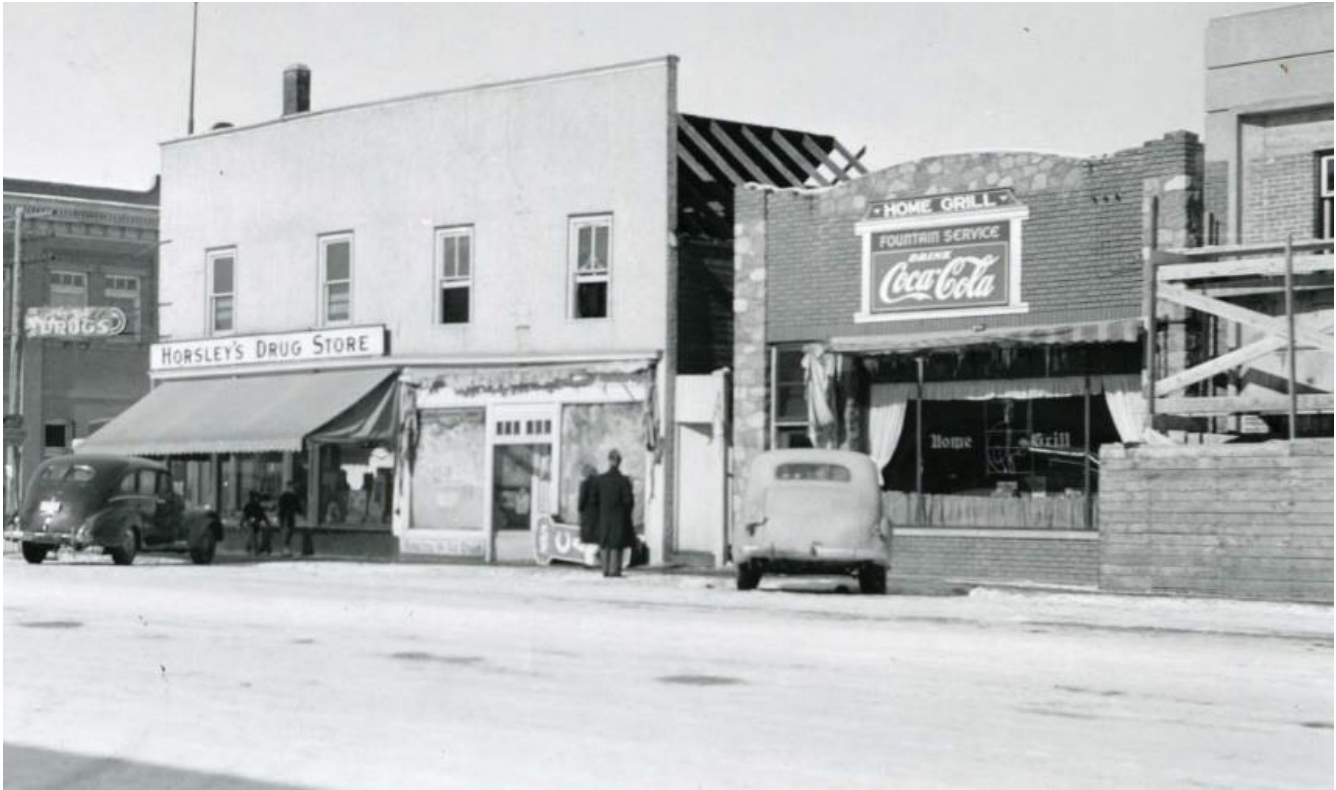
1947 Photograph of the Home Grill Building (Source: Red Deer and District Archives, P217).
