September 29, 2025

Project/File: 123317662

Lily Dam, M.Eng., P.Eng. The City of Red Deer Box 5008 Red Deer, AB T4N 3T4

Reference: 2025 Geohazard Site Inspections Summary for Various Sites in the City of Red Deer, Rev. 0

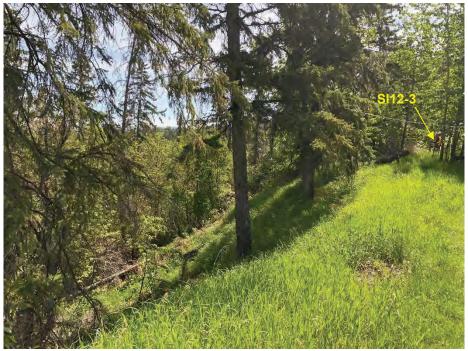
Photo 3: Well vegetated riverbank further west from SI12-3, looking east.

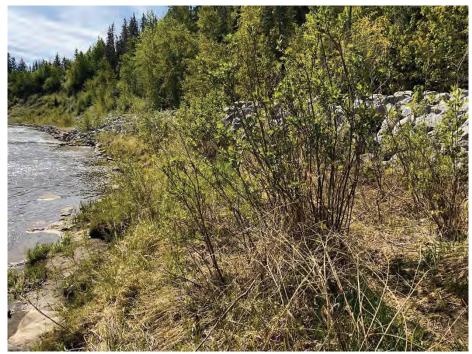
Photo 5: Toe of riverbank with riprap armouring. Looking southwest.

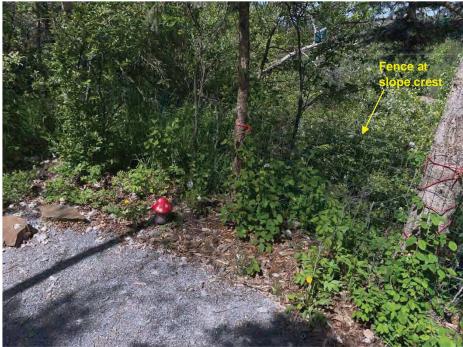
- A new shed and a flat gravel pad area were observed near the back of Lot 6 (Photo 1). A landslide in this zone would likely have a direct impact on the gravel pad. The shed appears to be inside the setback distance for a slope with a factor of safety of 1.3 based on Parkland Geo's (2014) analysis.

Photo 1: Gravel pad near crest of slope behind Lot 6. Facing northwest.

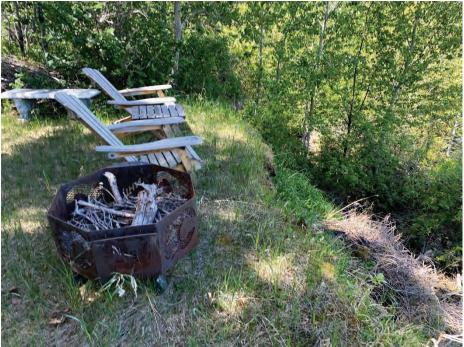
Photo 3: Slide area behind Lot 9. Facing west.

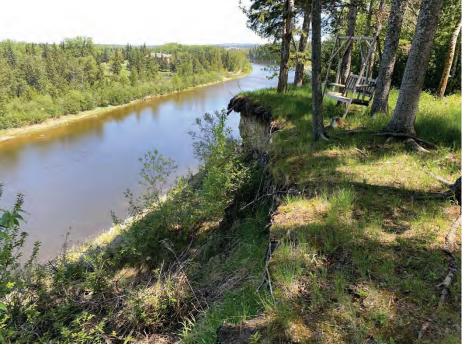
Photo 5: Slide behind Lot 11, looking from Lot 10. Facing east.

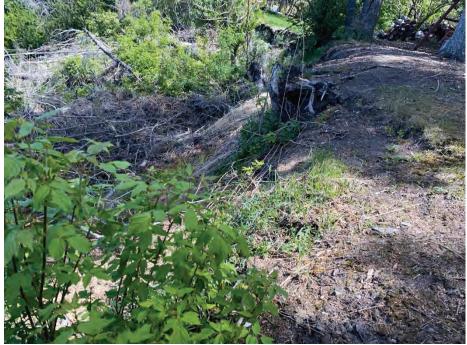
Photo 9: Landslide at Lots 17 and 18, taken from Lot 17. Facing east.

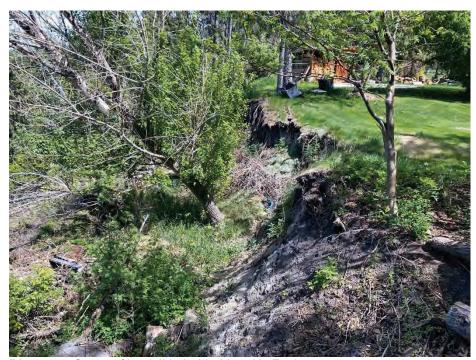
Photo 10: Scarp of landslide behind Lot 18. Facing east.

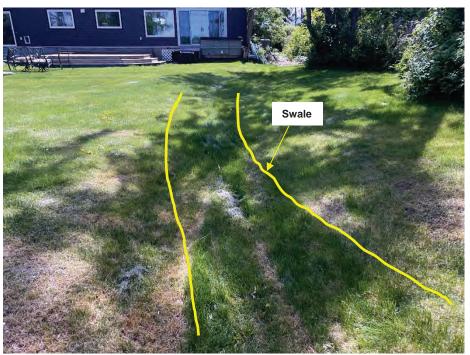
- A swale-like feature was observed on the west side of Lot 18 in the backyard. The swale appears to be draining towards the river valley slope (Photo 11) and does not appear changed from the 2022 site inspection.

Photo 11: Swale like feature at Lot 18. Appears to be draining north towards river valley slope. Looking south.

- The swale-like feature at Lot 18 should be regraded such that channelized surface water flow towards the river valley slope is reduced.
- Watering of back lawns should be avoided since addition of water into the slope could be detrimental to its stability.
- Any future lot development should plan for building development behind the FS = 1.5 setback. Utility services, cisterns, and septic systems should also be planned such that these structures are located as far away from the slope crest as possible.
- The recommended site inspection frequency for Site 2 remains at once every 2 years.

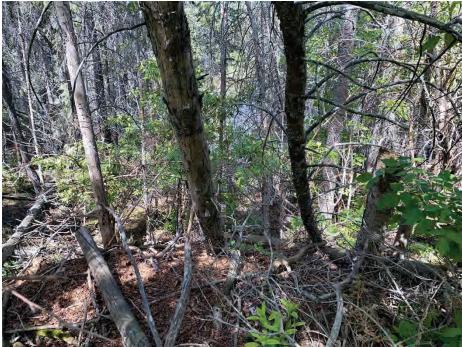
Photo 15: Slide behind Lot 21, looking downslope (east).

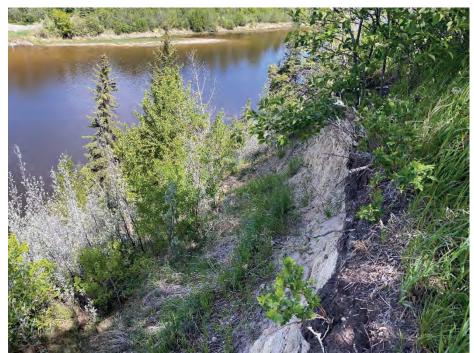
Photo 16: Slide at recreational trail lookout on Warwick Drive, facing northeast.

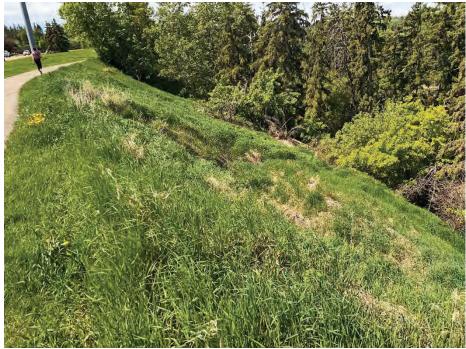
Photo 17: Slide at east end of Warwick Drive near recreational trail. Facing southwest.

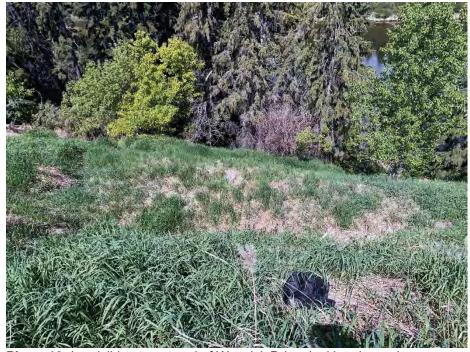
Photo 18: Landslide at east end of Warwick Drive, looking down slope.

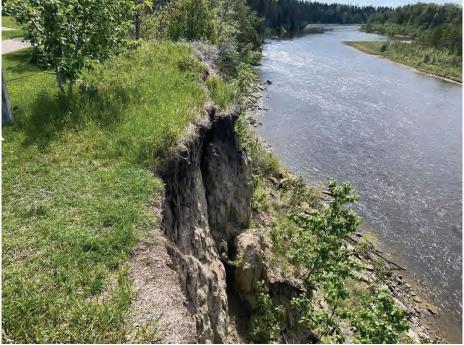
Photo 7: Historical slump at southwest end. Facing west.

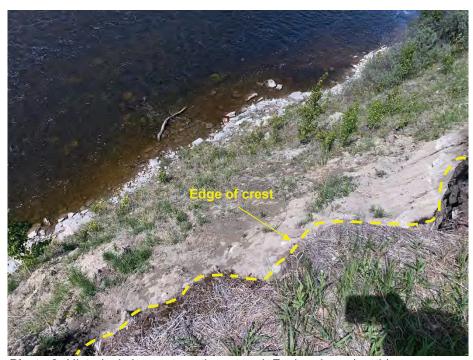
Photo 8: Historical slump at southwest end. Facing down (north).

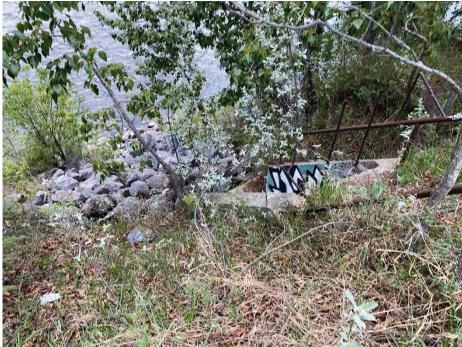
- Two outfalls were observed at the site, one near the end of 47 Street and the other beyond the bend of 45 Street, near the west end of the site. The one near the end of 47 Street consists of a large diameter pipe and the slope above it is reinforced with geoweb while the outlet area is protected from erosion by articulated concrete blocks (Photo 6). The other outfall at the west end of site outlets from a concrete structure onto riprap armouring the slope before entering the river (Photo 9).

Photo 9: Southwest outfall. Facing north.

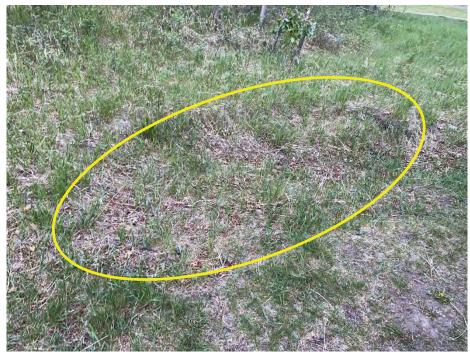
- A depression in the ground approximately 0.1 m deep, 1 m wide, and 3 m long was observed between the crest and the trail on the southwest end of site (Photo 10).

Photo 10: Ground depression between crest and trail at southwest end. Facing east.

- Regrade ground cracks and depressions along the crest to seal and reduce surface water infiltration into the slope. No additional fill should be placed for regrading. Any vegetation removed for regrading the landslide should be reinstated to maintain slope stability.
- If the failures begin to retrogress and the trail becomes at risk, potential remediation options for the slope may
 include reinforcing the slope with soil nails, constructing a pile wall or armouring/buttressing the riverbank.
 Alternatively, the trail could be realigned closer to 45th Street to provide a wider buffer from the crest of the
 river valley.
- Stantec recommends the inspection frequency of once every 5 years or "as needed" if signs of instability appear or if ground cracking and pavement cracking worsen.

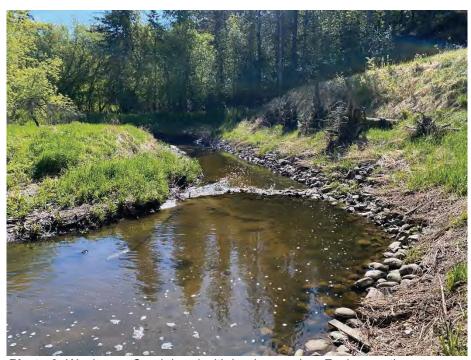
Photo 6: Waskasoo Creek bend with bank armoring. Facing southeast.

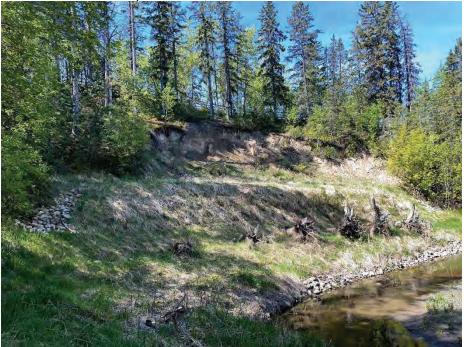
Photo 7: Landslide area on south bank of Waskasoo Creek, note exposed scarp face. Facing southwest.

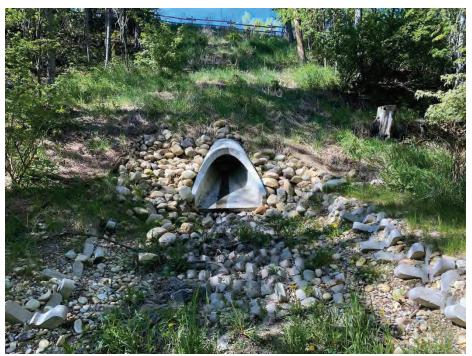
Photo 8: Outfall west of creek. Well vegetated above outfall. Facing southwest.

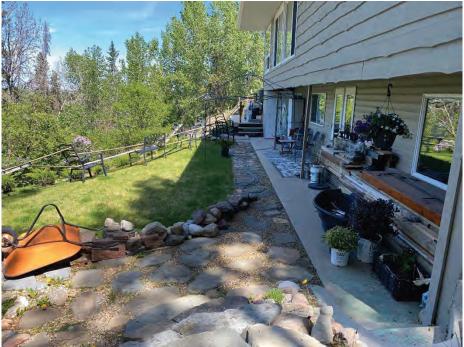
Photo 1: Back of house and remaining yard behind scarp, facing north.

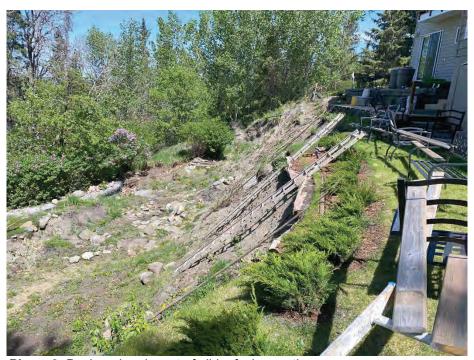
Photo 2: Backyard and crest of slide, facing north.

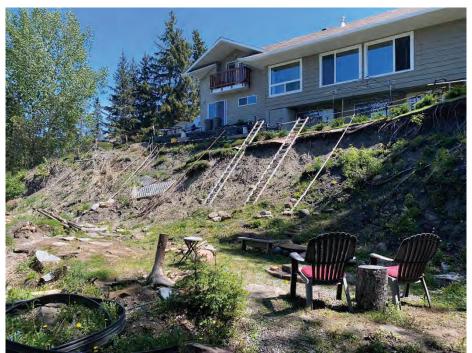
Photo 4: Backyard, landslide backscarp showing ~3.5 m drop. Facing northeast.

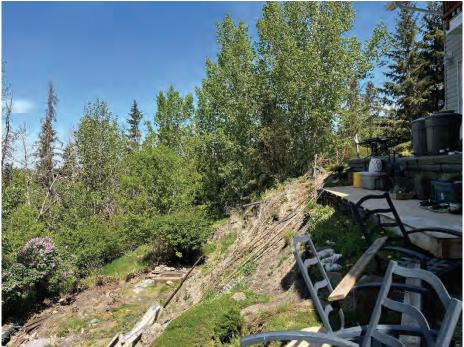
Photo 5: Backscarp encroaching the patio, facing north.

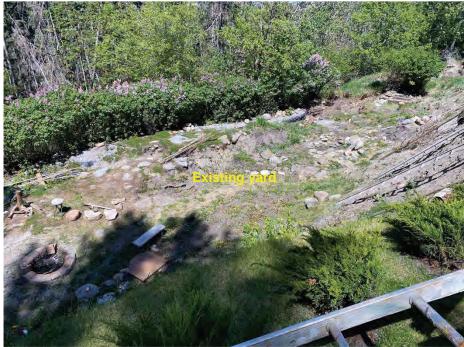
Photo 7: Landslide mass looking downslope (west).

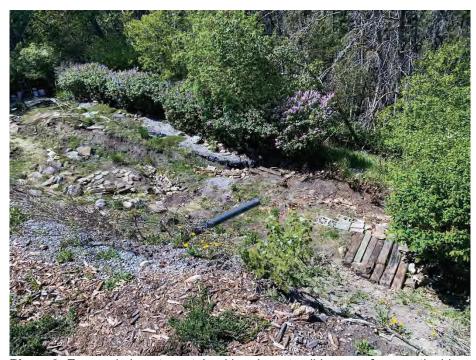
Photo 8: Exposed pipe at crest. Looking down to slide mass from north side of house, facing southwest.

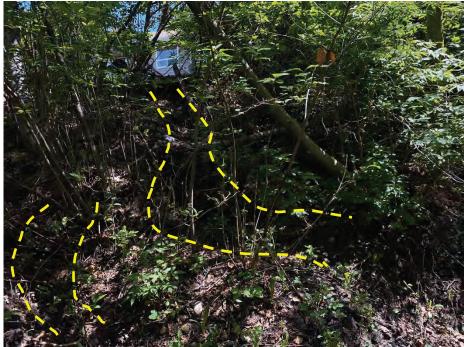
- Erosion gullying was observed in an area near the south side of the landslide, further downslope from the existing yard (Photo 11). This gullying may be the result of overland drainage through cracks formed in the slide mass during the slide event. The surrounding slope is moderately vegetated with shrubs and small trees.

Photo 11: Section of gullying behind slid portion of backyard. Facing east.

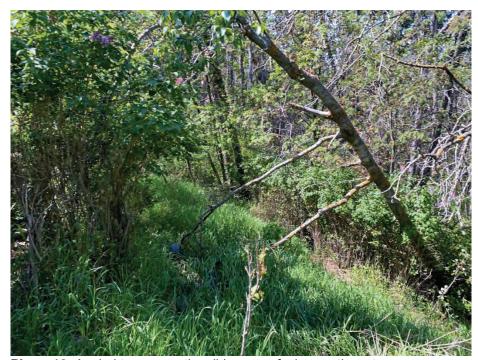
- Leaning trees were observed within the slide zone (Photo 12), and a toe bulge about 1.0 to 1.5 m in height was observed in the tree line, similar to 2022.

Photo 12: Angled trees near the slide mass, facing southwest.

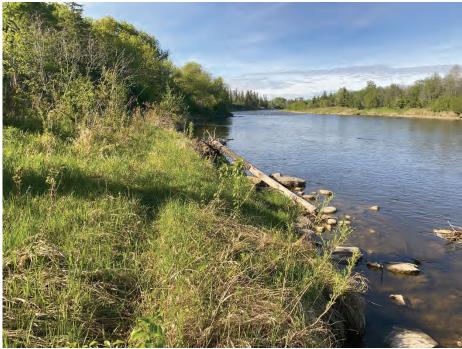
Photo 3: Toe of riverbank. Looking south from north end of site.

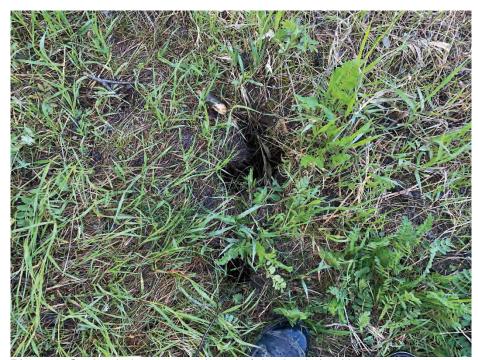
Photo 4: Gopher holes near north end of riverbank. Looking southwest.

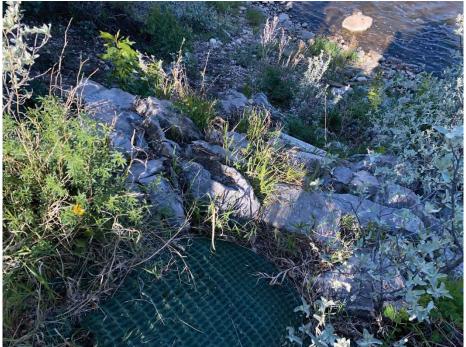
Photo 7: Erosion control blanket and riprap on riverbank slope. Facing southwest.

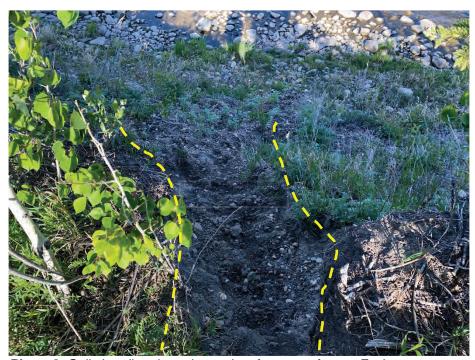
Photo 8: Gully heading downslope taken from top of crest. Facing west.

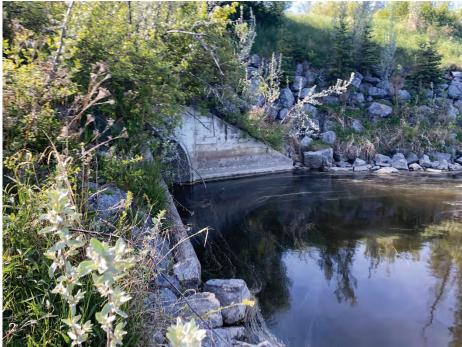
- Two outfalls were observed that discharged directly into the river; one outfall is located near the middle of the site, across from the Parkland School, and the other is located at the south end of the site (Photos 11 and 12). The outfall across from the school was constructed of concrete, with wing walls and riprap on both sides and some vegetation upslope. The southern outfall consisted of a steel pipe approximately 0.7 m in diameter, with a gabion wall built into the riverbank toe above it. Both outfalls were partially submerged in the river, and no flow was noticeable.

Photo 11: Outfall across from Parkland School. Facing south.

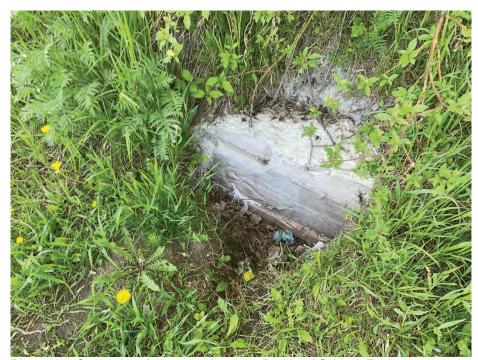
- A grouted outfall was located approximately 45 m southwest of the concrete outfall across from the Parkland School, near the toe of the riverbank (Photo 12). The grouted outfall was part of the City's work to plug an old sanitary pipe to the river. The grout is uncovered and visible; however, this area appears well vegetated with no signs of failure.

Photo 12: Grouted outfall across from the Parkland School. Facing east.

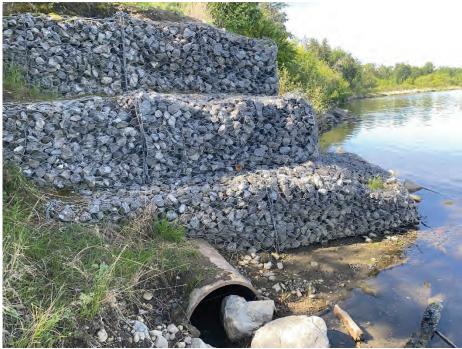
Photo 13: Southern outfall with gabion basket wall. Facing southeast.

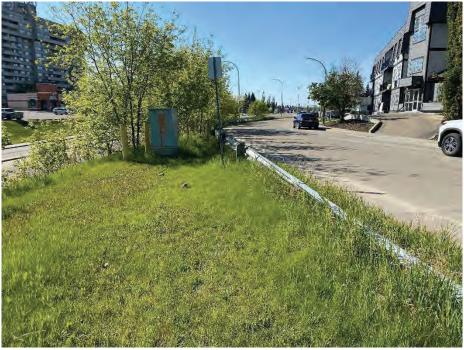
Photo 5: Crest of slope at north end of area. Facing south.

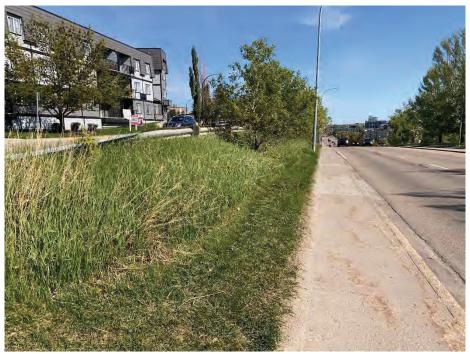
Photo 7: Slope at south end of embankment. Facing north.

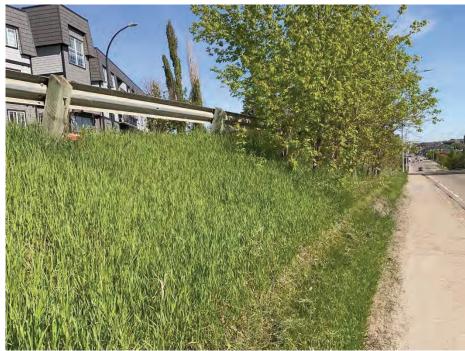
Possible creep of slope represented by cracking in asphalt and rotation of guard rail.

Photo 8: Slope near mid-section of embankment with leaning guardrail posts. Facing north.

- Seal pavement cracks to reduce surface water infiltration into the slope.
- The slope appears to be relatively slow moving and has not impacted any structures or City infrastructure at this time. However, additional creep of the slope or slumping due to land use, wet weather, etc., may result in loss of infrastructure. Potential remediation options for the slope may include slope flattening (reducing the service road to a single lane), removal of the landslide mass and replacement with engineered fill, reinforcing the slope with soil nails, or constructing a retaining wall.

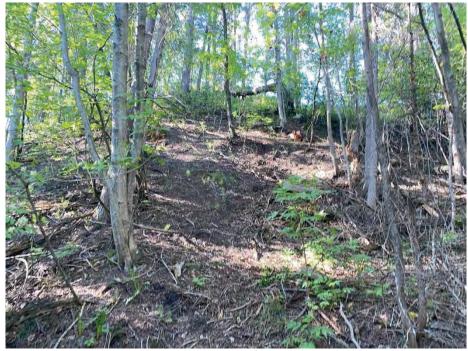
Photo 1: Slope area northeast of 4806 36th Street. Looking upslope (south).

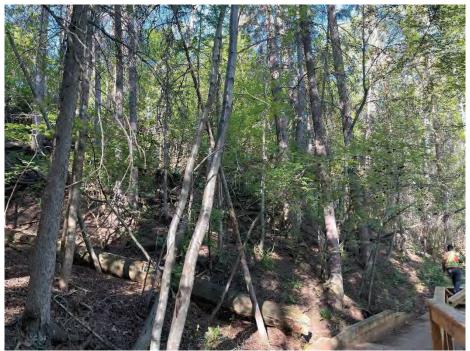
Photo 2: Slope area near 4806 36th Street. Facing west.

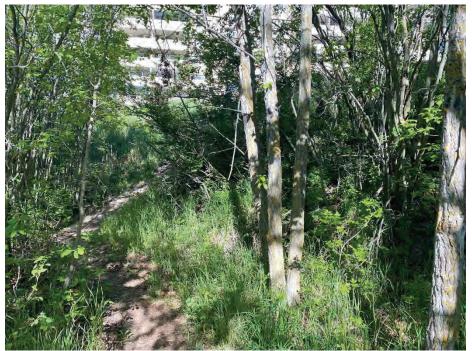
Photo 6: Slope area east of apartment complex. Looking upslope (west).

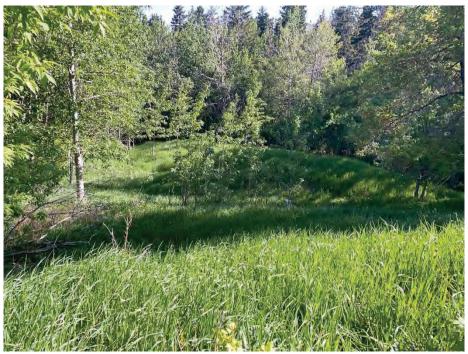
Photo 9: Well vegetated slope north of apartment complex. Facing north.

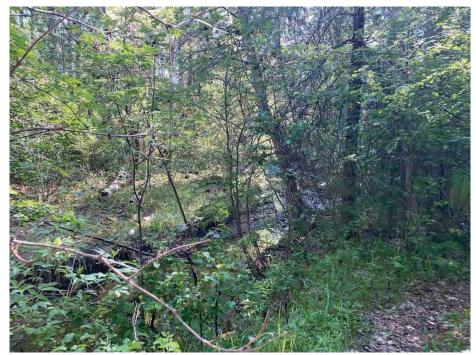
Photo 16: Piper Creek area northeast of former Elks building. Facing northeast.

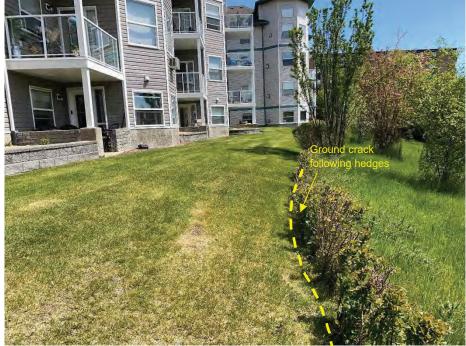
Photo 3: South yard. Looking east.

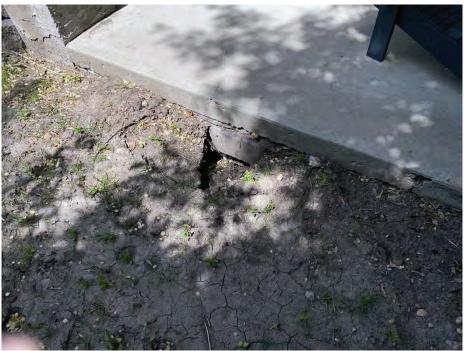
Photo 4: Hole in ground adjacent to far east unit patio slab at east building. Looking northwest.

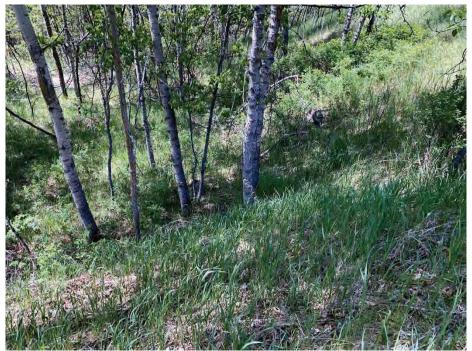
Photo 6: South slope face. Looking west.

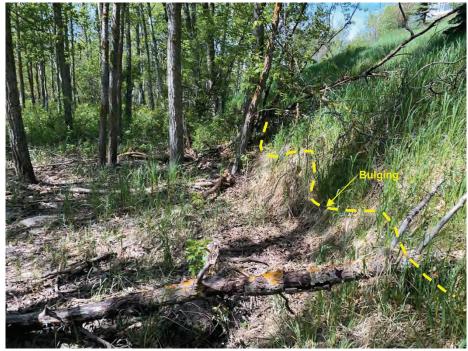
- Toe bulging was observed at the base of the slope similar to 2022 (Photo 9). Leaning trees were observed
 adjacent to the toe.
- The failure mass appears somewhat less vegetated (e.g., less trees) than surrounding areas, similar to 2022 (Photo 10).

Photo 9: Toe of south slope with angled trees and bulging. Looking west.

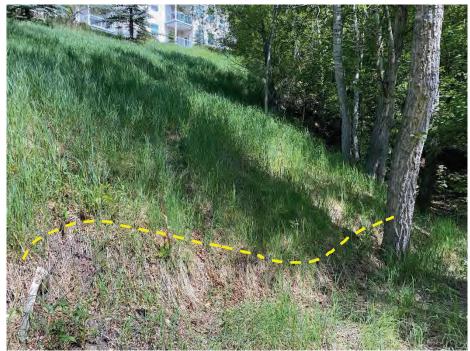
Photo 10: Toe bulge at south slope. Looking north.

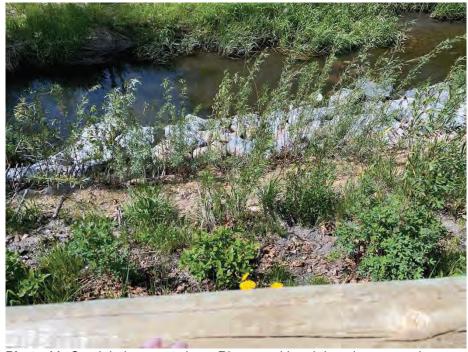
- An outfall is present at the creek to the west of the site, and was recently upgraded. Riprap lines the creek bank around the outfall, and an erosion control blanket was placed upslope (Photo 11).

Photo 11: Creek below west slope. Riprap and brush layering on creek edge. Looking west.
